Tputty 607 Thermal Reliability

This report summarizes the thermal reliability testing of Tputty 607. This reliability test procedure is designed to characterize the long term performance of the dispensable thermal gap filler by subjecting the material in the test fixtures to isothermal conditions, repeated thermal shock conditions, and moderate heat and high humidity conditions. The test fixtures feature an isolated sample platform with an area of 12mm x 14mm. Three of these isolated sample platforms are featured on a single test fixture with isolated heating and temperature monitoring for each sample. As an addendum, samples at 1.5mm and 2.2mm were performed in a vertical orientation.

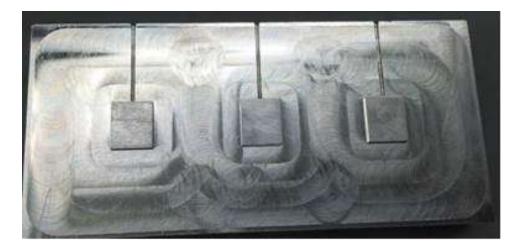
Figure 1: Test Fixture Hot Plate Sample Surface

Each assembly, with sample, is tested at time zero and then placed into the conditioned chambers for the specified period of time. Generally, every 250 hours the assembly is removed, tested and then placed back into the chamber. Figure 1 shows a detail of the hot plate surface, providing a visual of the isolated and raised sample platform. See figure 2 for an image of the test fixture with dual fan in place for testing.

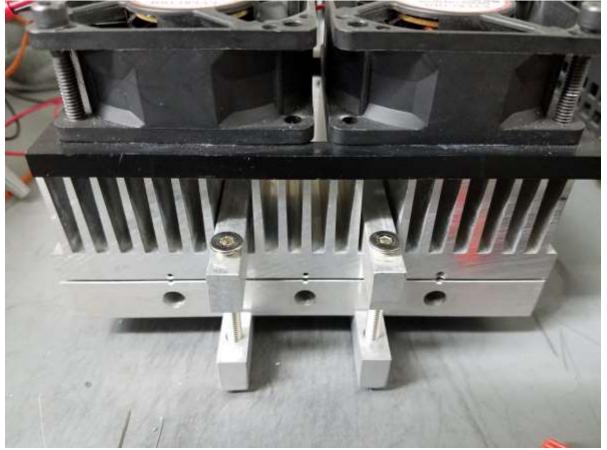
Figure 2: Test Fixture Assembly with Fan
